SCAN MARINE/WALLAS Service Bulletin 070602

June 18, 2007

Re: Wallas 270 blower bearing re-alignment.

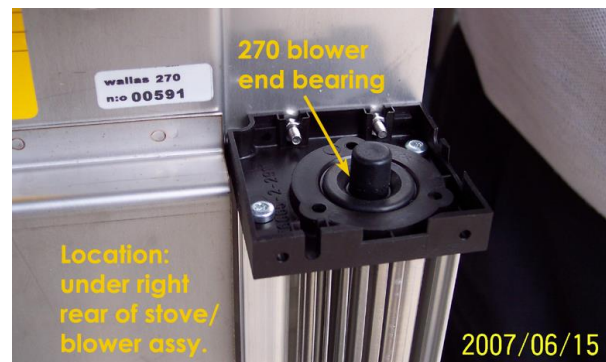
Symptom: Loud dragging or rattling noise when blower lid is activated.

The Wallas 270 blower end bushing sometimes gets pushed out of position during shipping & handling. This can be very quickly solved by following the instructions below:

1. Locate the blower end bushing located under the right rear side of the stove/blower assembly.
