SCAN MARINE/WALLAS Service Bulletin 070703

July 3, 2007

Re: Wallas 85DU heat indicator plug installation.

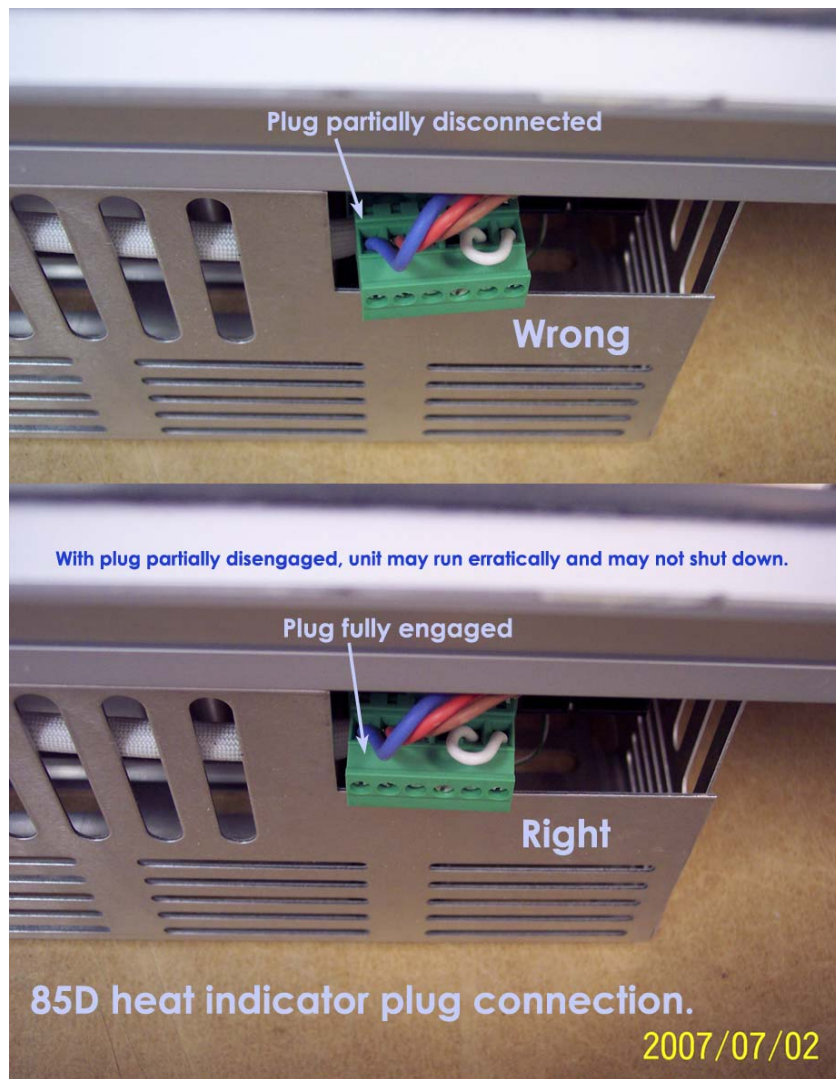
The Wallas 85DU comes fully assembled with all wiring connections made up as part of the final assembly process. Sometimes during stove installation, with or without the 270 lid, the green connector to the heat indicator lamp at the front of the stove gets jarred partially or completely loose. Please see the picture, below.

If this connection is incorrect, the stove may run, but not respond to the shut down command, it may run erratically or not run at all. Simply push the plug back into place before running the unit again. As a normal part of any troubleshooting process, please verify ALL electrical connections are made up properly.

This problem should be limited to the 85DU, but check this connection if you experience any of the above symptoms on your 85DP as well.
